Manhole Inspection Summary

Manhole # S39I__039MH

Insp Date: **7/9/08 9:20 AM**

Location Address: **221 s. high st**

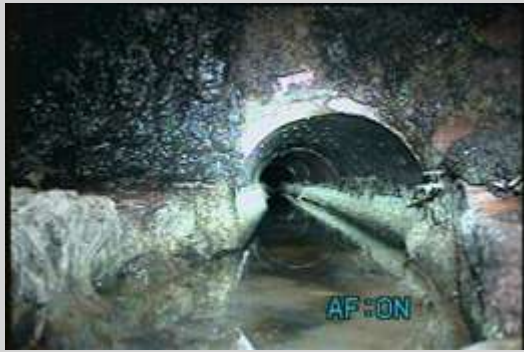
6 O'Clock Inflow

8 in. Circular Gravity Sewer

Pipe In @ 6 O'Clock

Pipe Height: 0 (in.) Direct

Pipe Material: **Clay** ☐ Pipe Lined

Infiltration: **None** Pipe Seal Cond: **Unknown**
